FORM B – BUILDING

Town Lexington

Address 7 Fletcher Ave.

BUILDING FORM

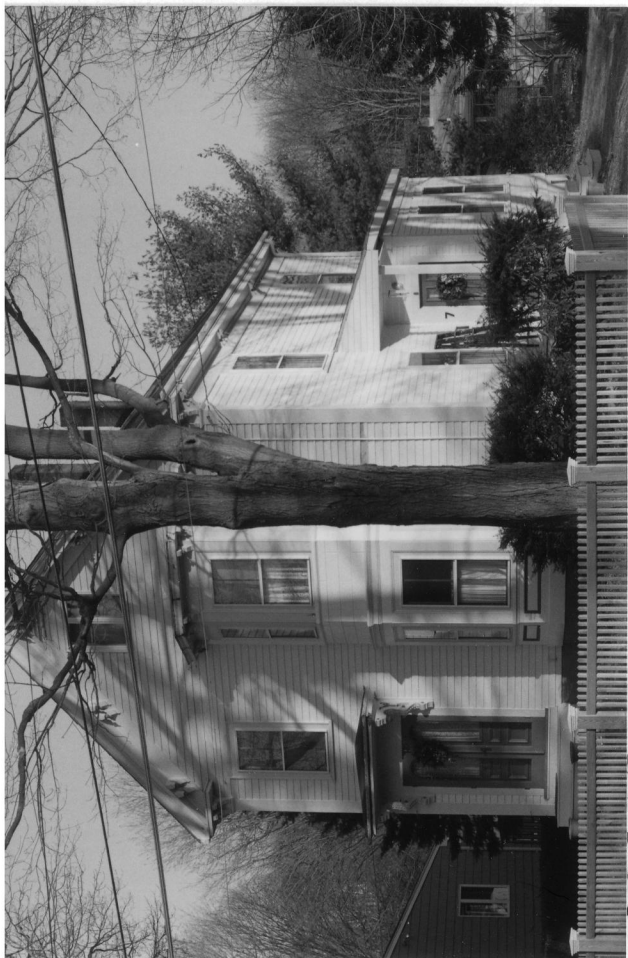
7 Fletcher Ave. is one of a number of front-gabled Italianates in Lexington. The house is rectangular, 2½ stories, two-by-three bays, and front-gabled with two side chimneys. It is set on what appears to be a concrete foundation but could be just concrete veneer, clad with wood clapboards, and roofed with asphalt shingles. There are one-story shed-roofed additions on the south and rear elevations. The Italianate finishes are very similar to those on 8 Fletcher Ave. (MHC #671) directly across the street: paired brackets at the cornice (those on this house have drops), a two-story three-sided bay on the facade, milled brackets under the entry hood (again with drops), and a double front door with roundhead lights. There is, however, no one-story three-sided bay on either side of this house as there is at 8 Fletcher. At the rear is a three-car garage.
